TO : Mike Zimmerman, OSC
FROM : Scott Keen, E & E TAT *SK*
DATE : February 2, 1993
SUBJECT: Richardson Flats Data
T08-9210-041

TO: Mike Zimmerman, EPA-OSC
FROM: Cordel Schmidt, TAT
DATE: January 4, 1993
SUBJECT: Transmittal of Sampling Activities Report for the
Richardson Flats Site, Summit County, Park City, Utah.
TDD# T08-9210-041.

REPORT OF SAMPLING ACTIVITIES
RICHARDSON FLATS TAILINGS SITE
PARK CITY, SUMMIT COUNTY, UTAH
TDD #T08-9210-041
PAN EUT0039SCA

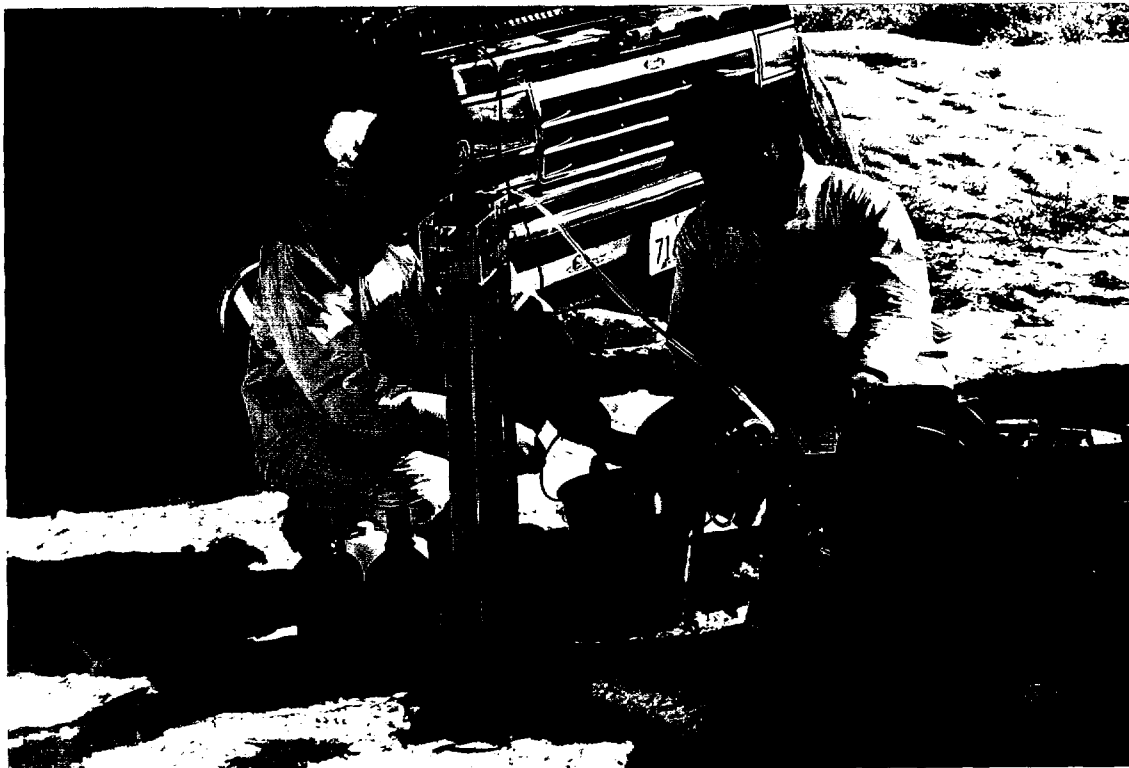
Location: Richardson Flats Tailings Site; monitoring well RF-MW-01

Subject: TAT obtaining VOA sample via peristaltic pump

All sampling operations were conducted in Level D personal protective equipment and included the use of Tyvek suits and "surgical" nitrile gloves. Sampling at location RF-MW-01 was achieved by the use of a peristaltic pump with which dedicated silicone and Tygon tubing was used to pull water from the well and deposit it directly into a collection vessel. Note that all collection vessels (i.e., poly bottles for metals analysis, amber glass for BNA/pesticides/PCBs analysis, glass vials for volatile organics analysis) were laboratory decontaminated prior to use by the TAT. Sampling at locations RF-MW-02 and RF-MW-03 was achieved by means of dedicated Teflon bailers which were lowered into the wells by dedicated poly rope. Water samples were then poured from the bailer into respective collection vessels. Samples at each location were collected in order of 1) VOA, 2) BNA, 3) Pesticides/PCBs, 4) unfiltered metals, and 5) filtered metals. Metals were filtered at each well by use of a peristaltic pump which forced the sample through a .45 micron filter and into a poly bottle. Samples were shipped for laboratory analyses on November 10, 1992 via Federal Express. Note that organics were preserved with wet ice during sampling and shipping, while inorganics were preserved with nitric acid to pH \leq 2.

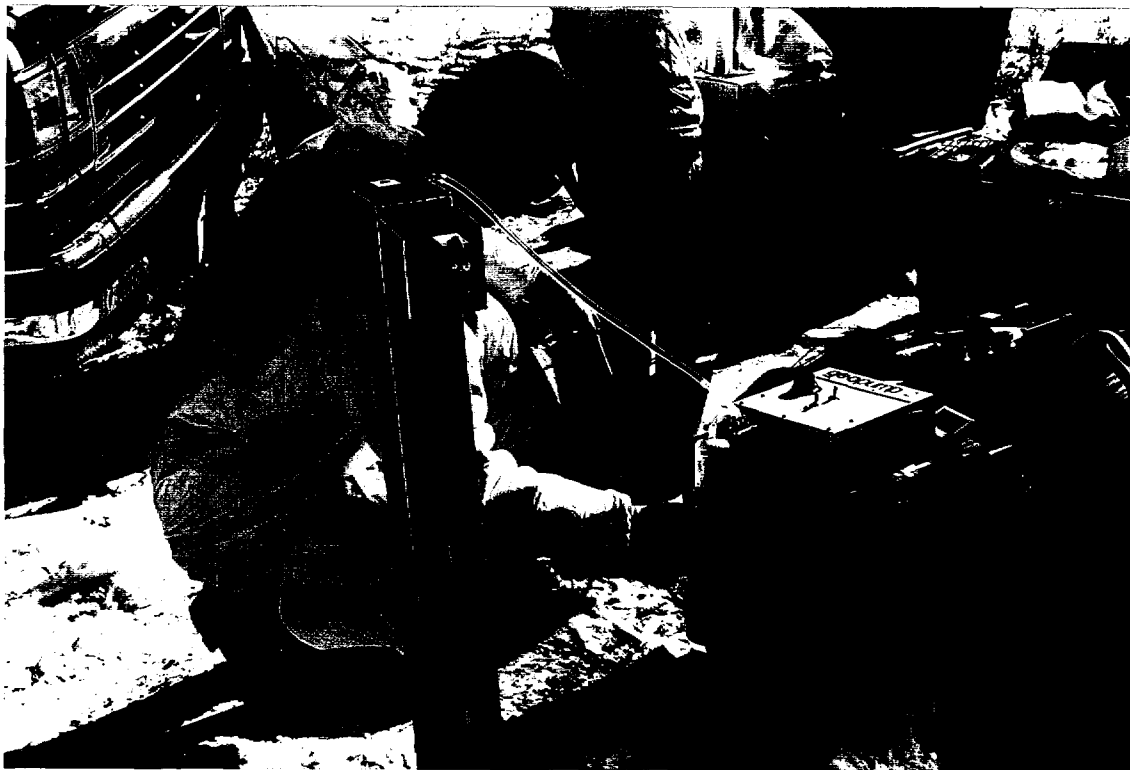
Location: Richardson Flats Tailings Site; monitoring well RF-MW-01

Subject: TAT filtering metals sample via peristaltic pump and .45 micron filter

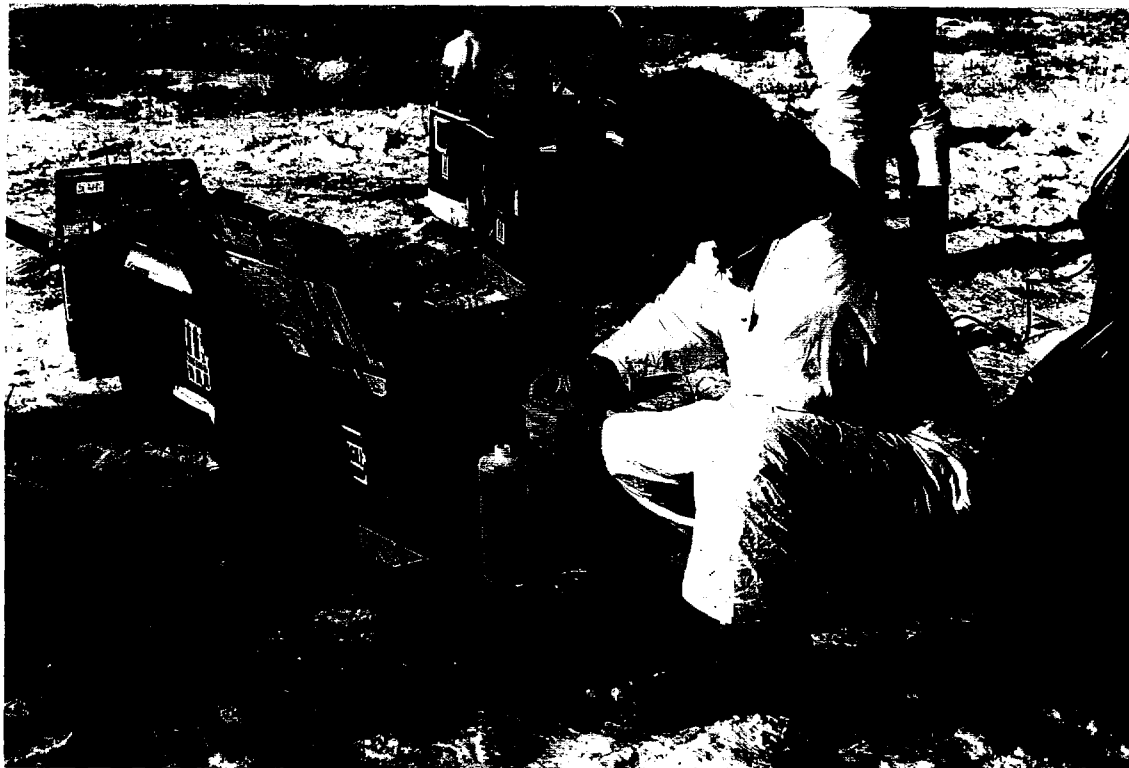
Location: Richardson Flats Tailings Site; monitoring well RF-MW-01

Subject: TAT preserving (acidifying) a metals sample

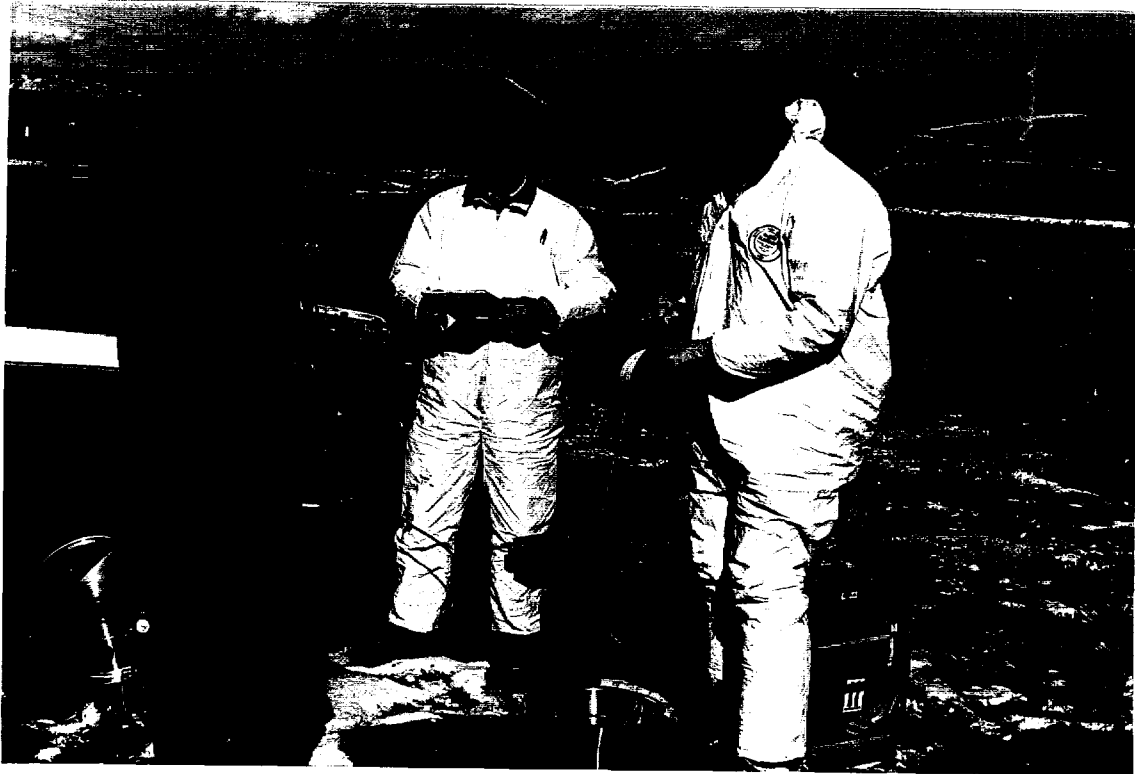
Location: Richardson Flats Tailings Site; monitoring well RF-MW-02

Subject: TAT obtaining water level measurements

TAT sampling operations did show that the water levels in each well have continued to decline since well installation. Sampling activities were photodocumented and are presented in Appendix A.

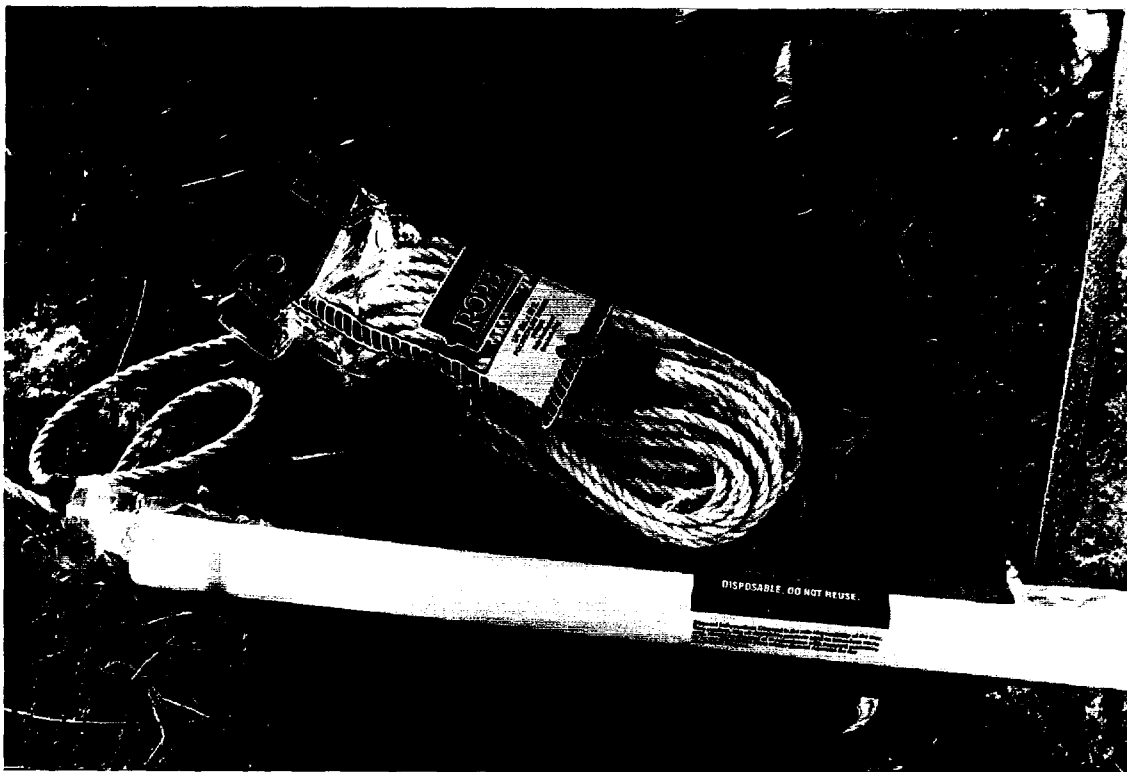
Location: Richardson Flats Tailings Site; monitoring well RF-MW-02

Subject: Disposable bailer and rope

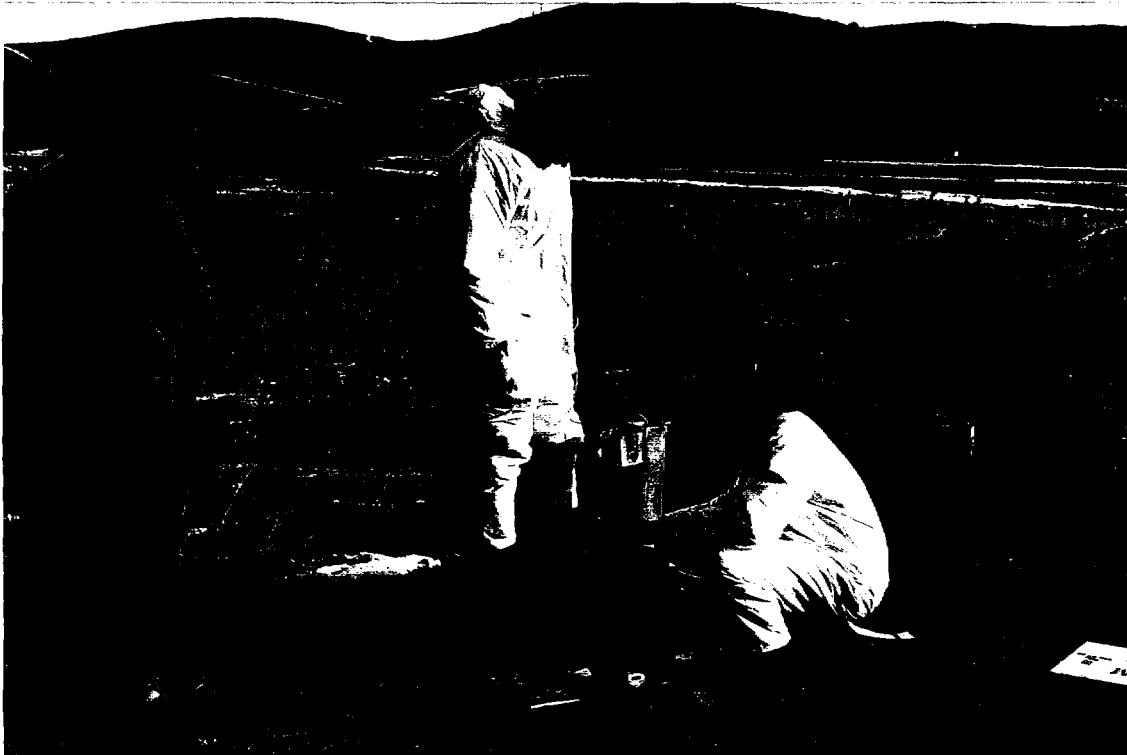
Location: Richardson Flats Tailings Site; monitoring well RF-MW-02

Subject: TAT obtaining pH, specific conductivity, and temperature measurements

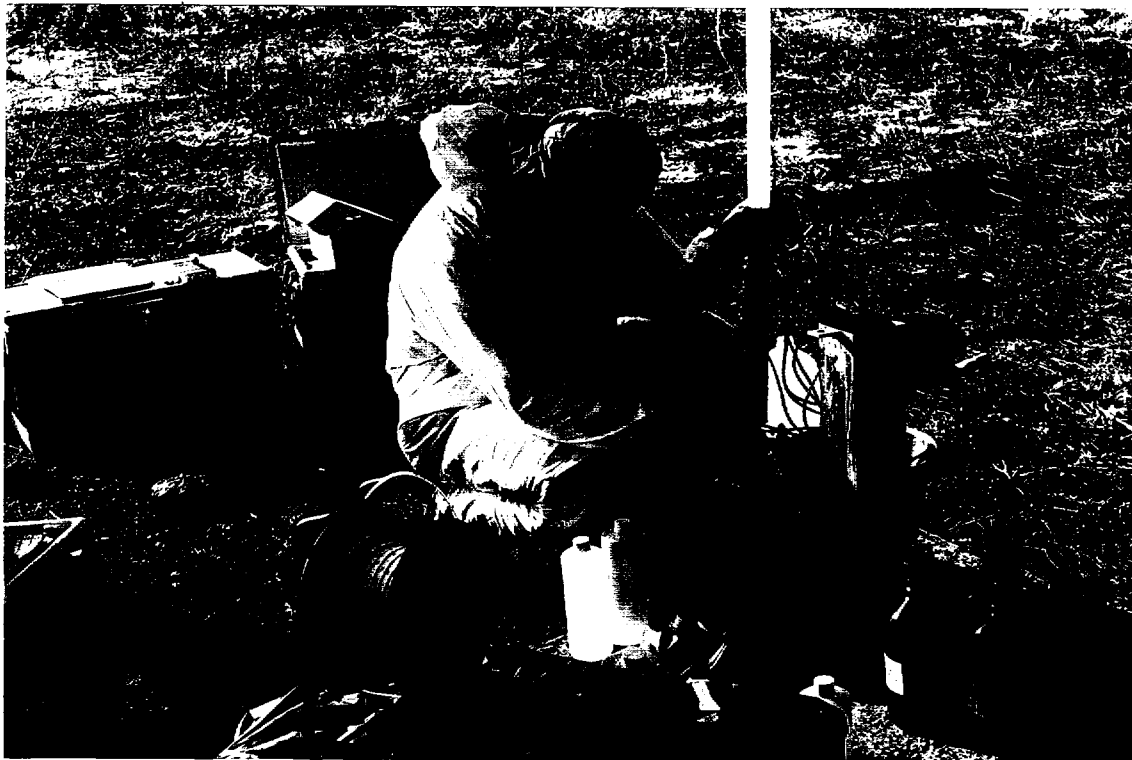
Location: Richardson Flats Tailings Site; monitoring well RF-MW-02

Subject: TAT obtaining samples via bailer

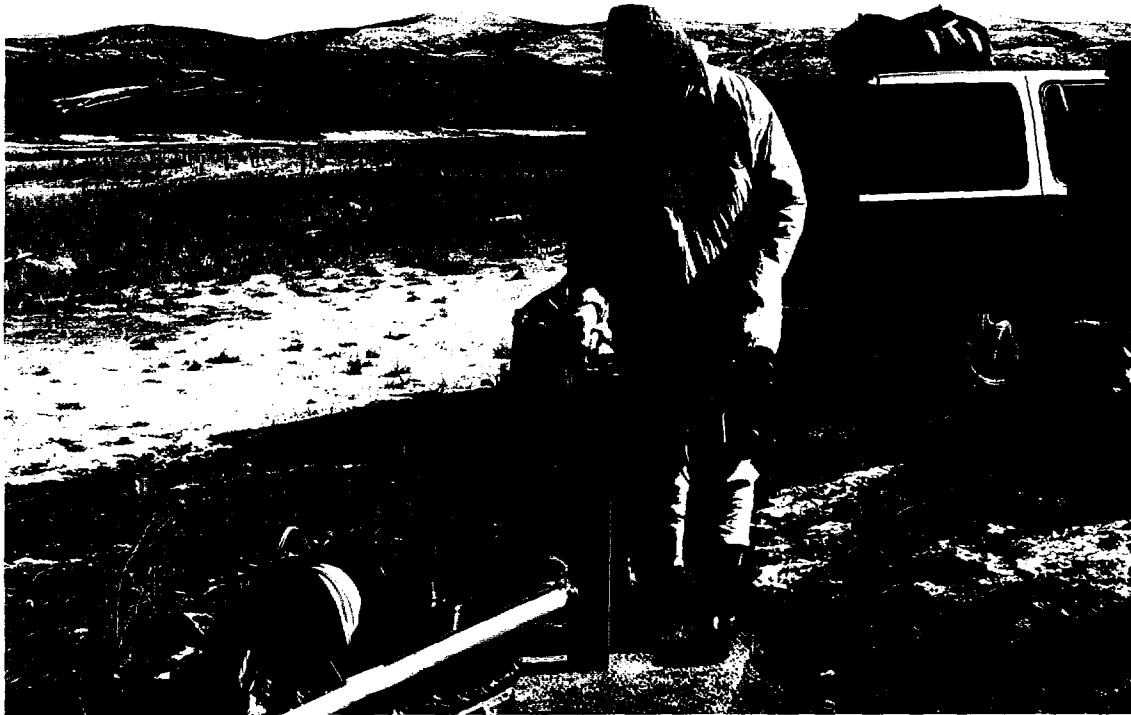
Location: Richardson Flats Tailings Site; monitoring well RF-MW-03

Subject: TAT obtaining initial OVA readings upon opening well

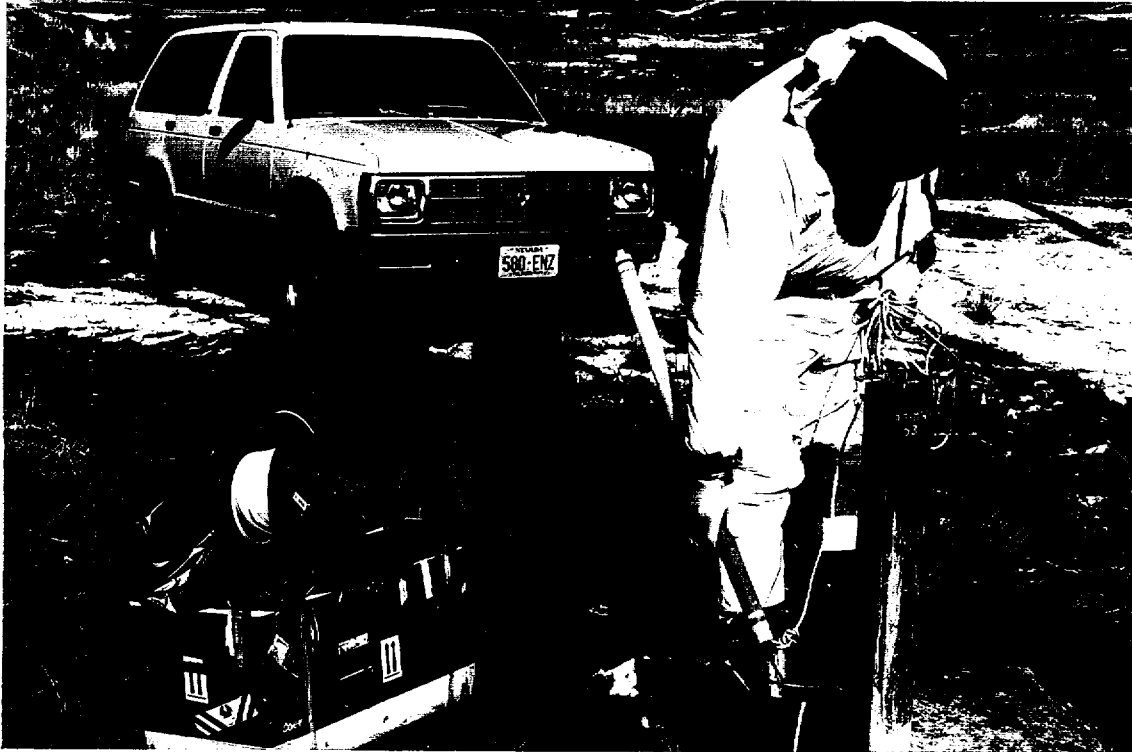
Location: Richardson Flats Tailings Site; monitoring well RF-MW-03

Subject: TAT bailing (purging) well prior to sampling

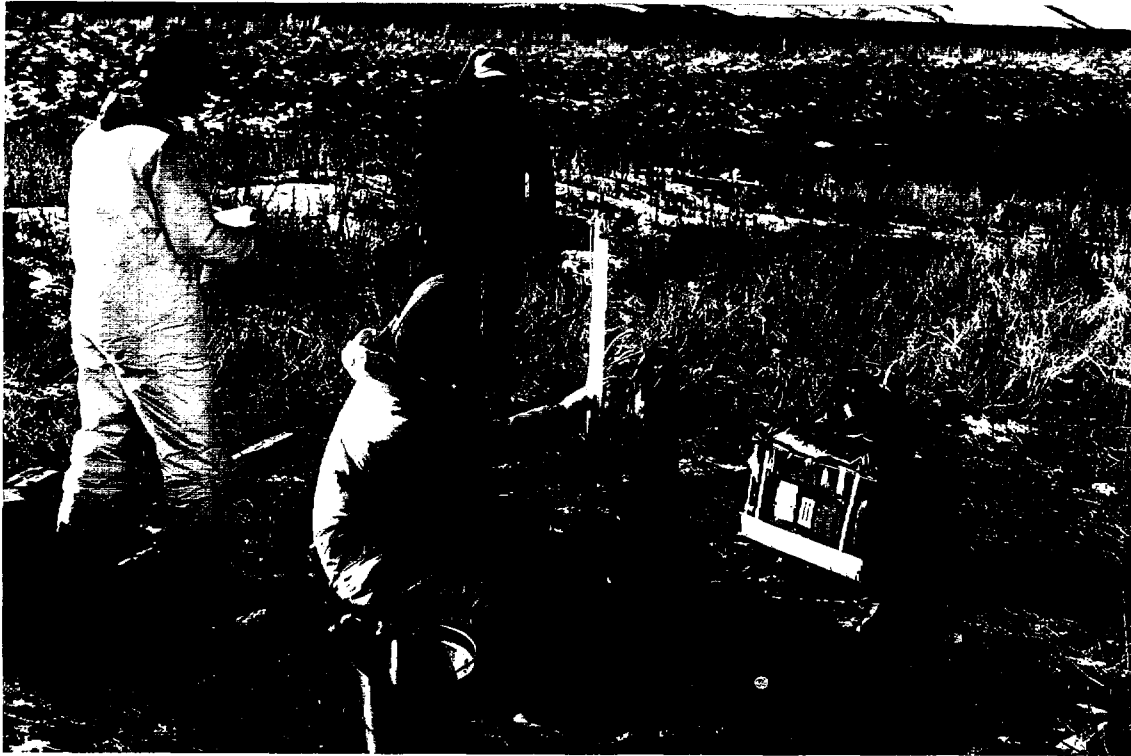
Location: Richardson Flats Tailings Site; monitoring well RF-MW-03

Subject: TAT obtaining samples via bailer

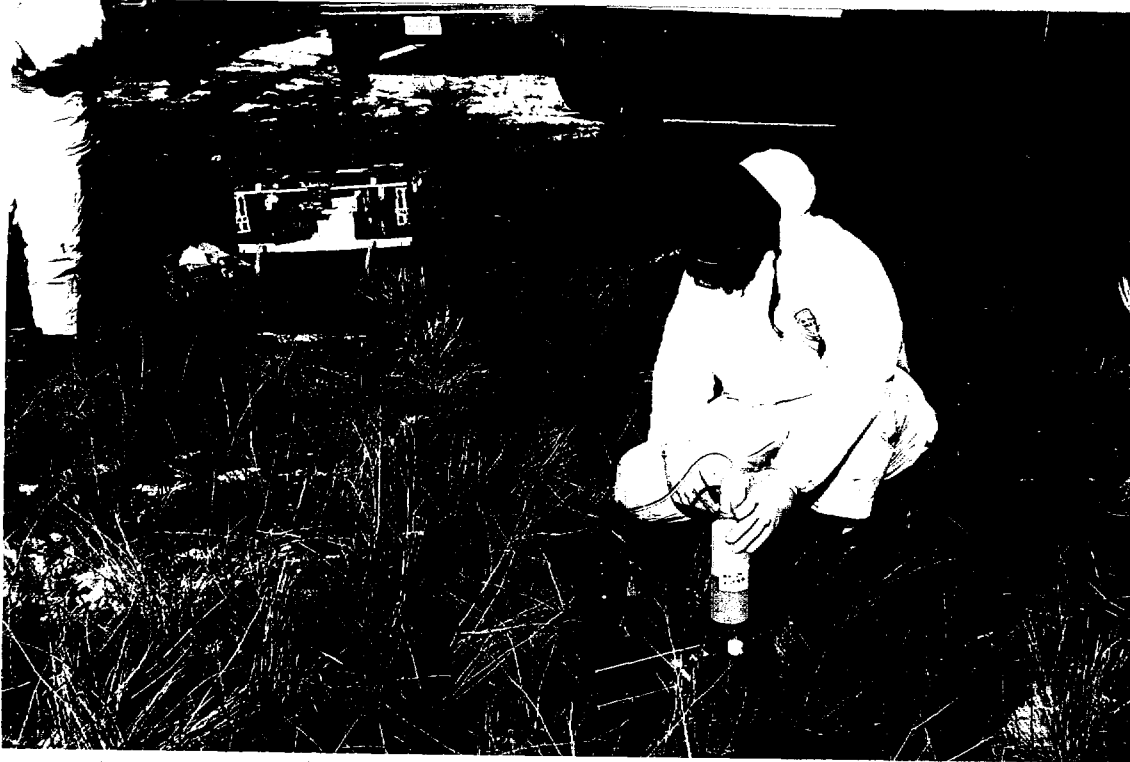
Location: Richardson Flats Tailings Site; monitoring well RF-MW-03

Subject: TAT filtering metals sample via peristaltic pump and .45 micron filter
